**Evaluation of Unpainted Weathering
Steel Bridges in Idaho**

**FINAL REPORT
FHWA-ITD-RP117**

Richard A. Jobes, PE

August 1, 1996

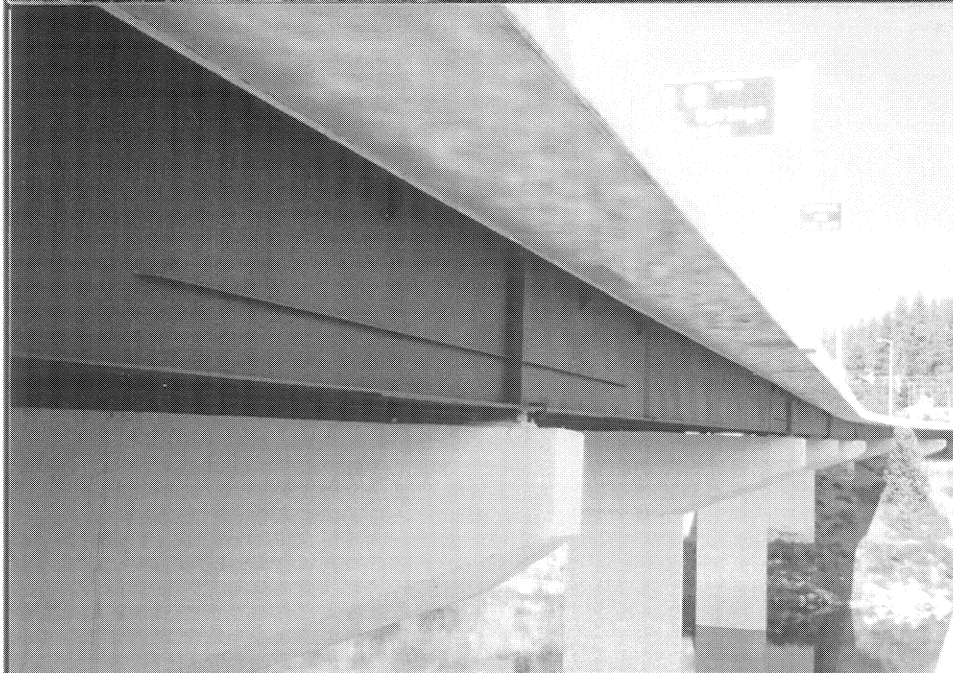
Photo No. 2
View of east exterior
girder. Note the uniform
dark color of girder and
no stains on pier.

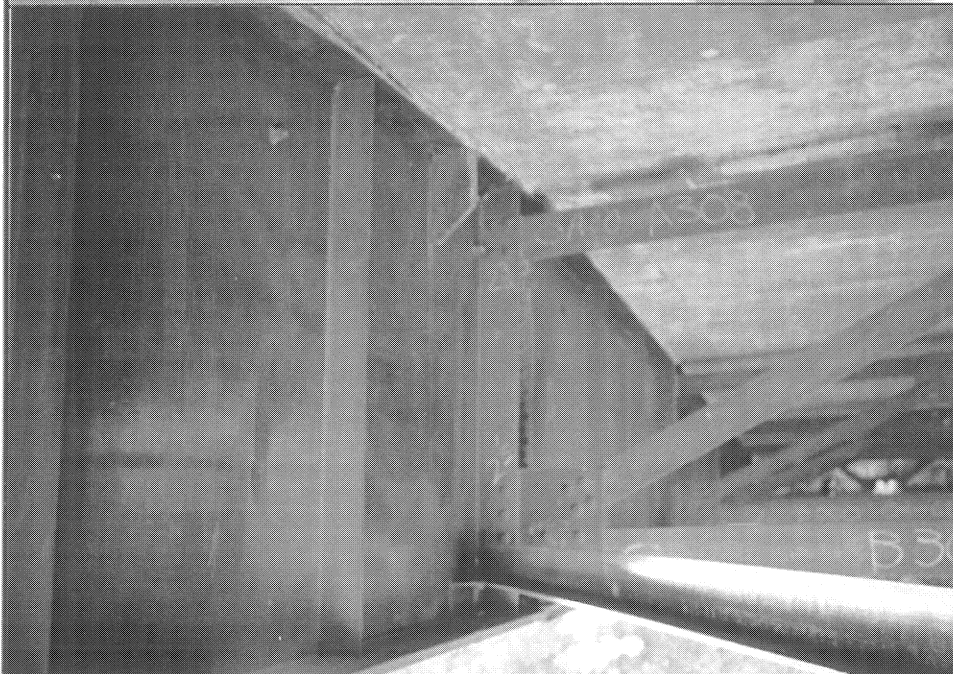
Photo No. 3
View of interior bay
showing cross frames and
lateral bracing. Note mill
scale and non-uniform
appearance

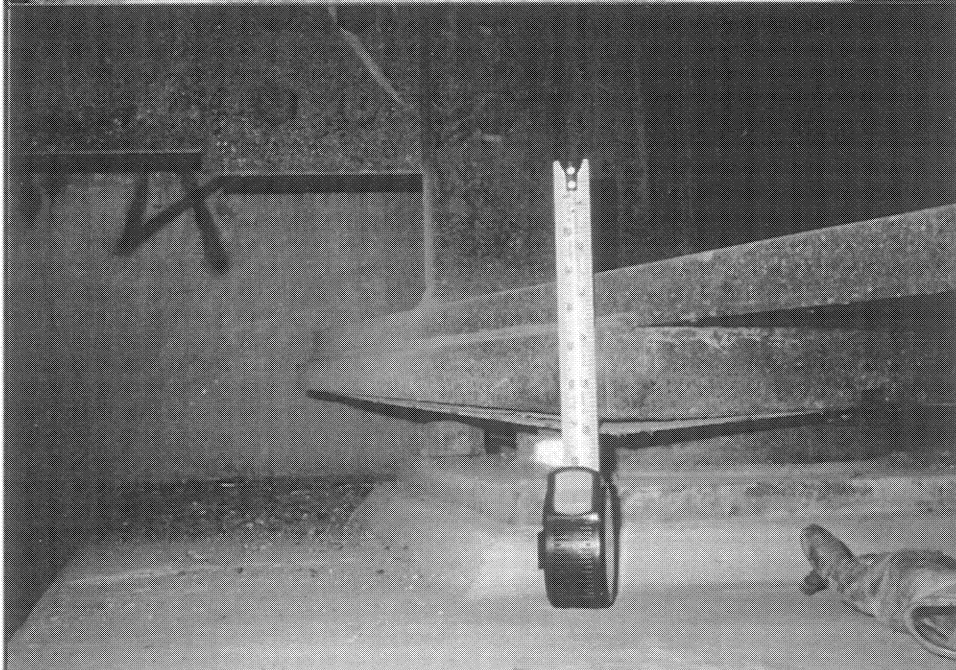
Photo No. 5
Expansion pot bearing at
abutment. Note stainless
sheet has come loose
from upper plate.

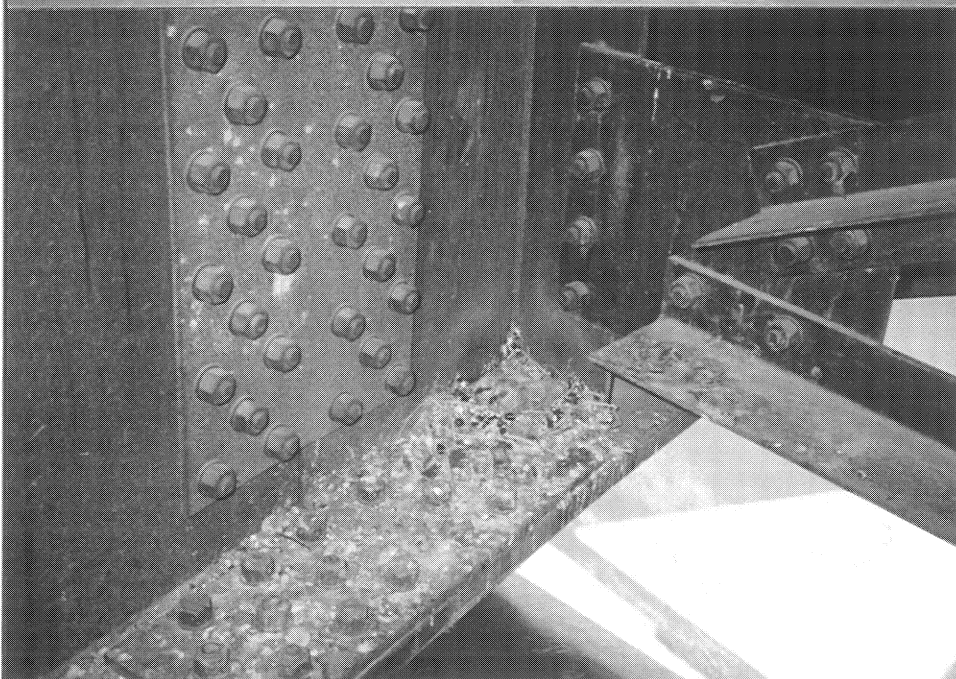
ACCUMULATION OF DEBRIS: Bird nests and bird-droppings were found on several of the I girder bridges. Corrosion from bird nests was evident at one field splice on the American Falls Bridge. Also, loose mill scale was found on the top of I girder bottom flanges. Debris from construction was found inside the box girders on the Ninth St. Bridge. Dirt, gravel, bird-droppings and other material was found on some beam seats. For instance, 3 inches of debris was found on pier 1 of the Broadway Bridge. Except as noted above the steel surfaces were found to be reasonably clean with no significant accumulation of dirt. The exterior surfaces of the steel box girders were found to be exceptionally clean.

Photo No. 6
Bird nest on bottom
flange at cross frame
connection.

In order to prevent additional corrosion, it is important to remove all bird nests and accumulations of debris on all steel surfaces. ITD's Reachall has recently been outfitted with a high-pressure washer. This equipment can provide access to all areas of the bridge superstructure for cleaning of beam seats and steel surfaces. It is expected that a program to clean all Idaho weathering steel bridges will be implemented in 1996.

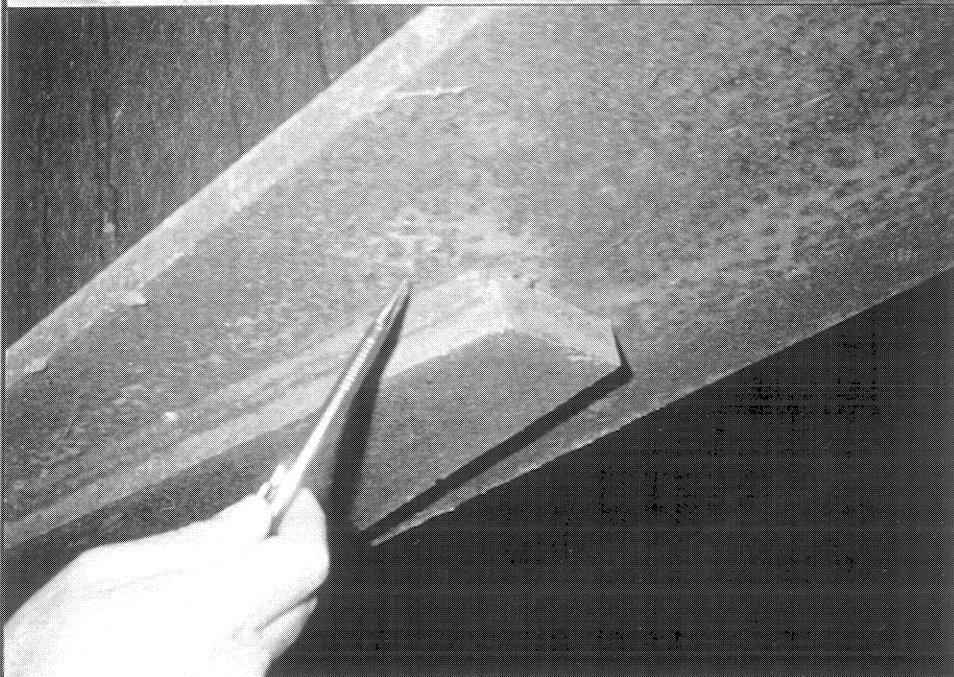
Photo No. 9
Cover plate on bottom
flange. Note mill scale
and light oxide coating.

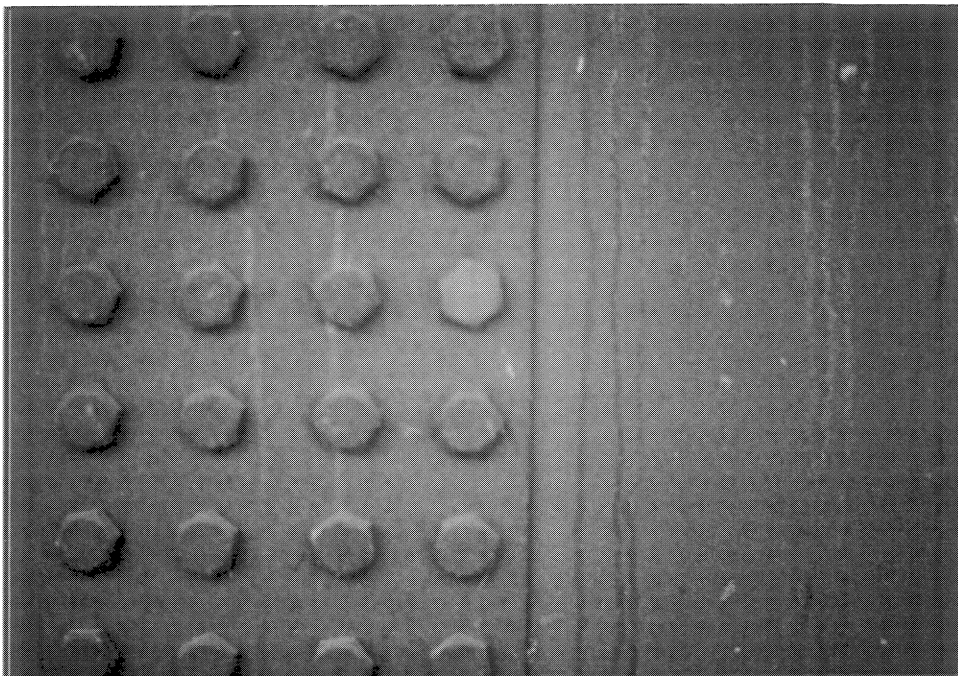
Photo No. 10
Interior view of bolted
web splice. Note dark
color and no corrosion.

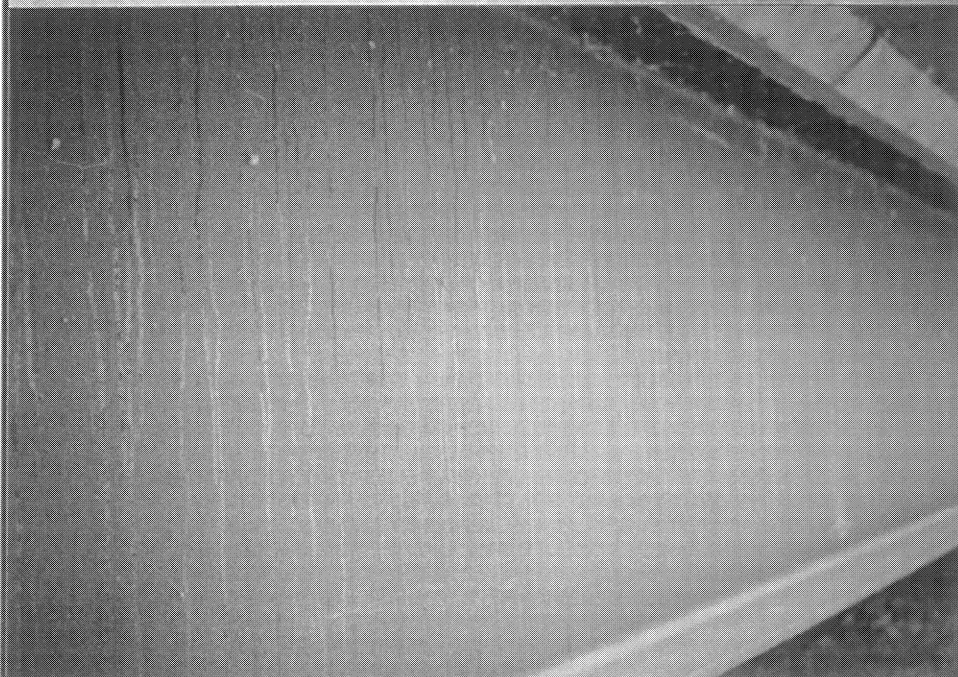
Photo No. 12
View of exterior face of
web showing vertical
lines from condensation.

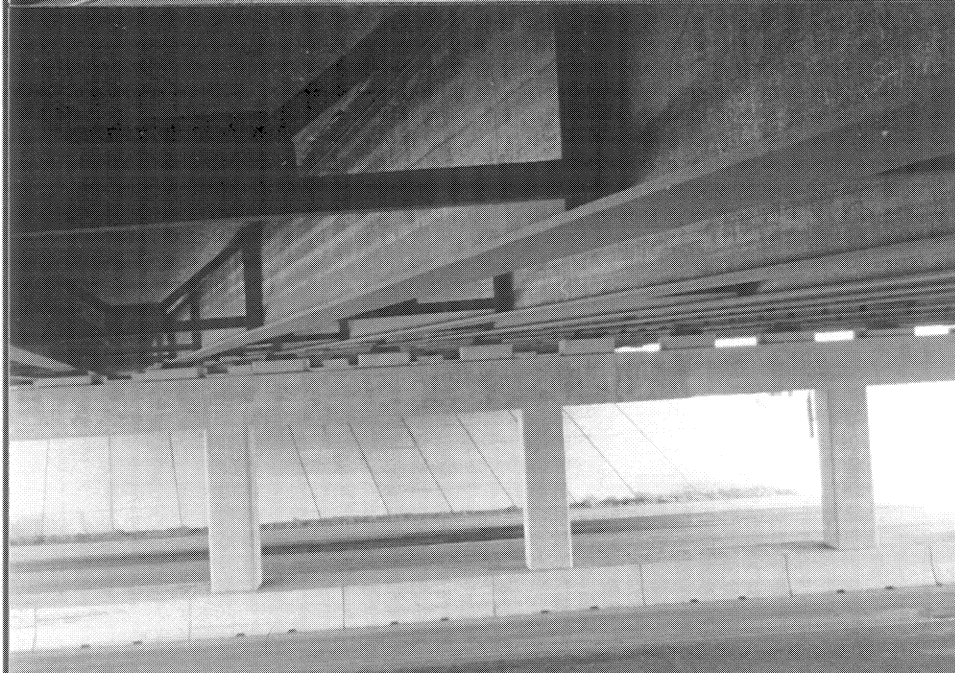
Photo No. 14
View of pier and
underside of steel
superstructure from north
side. Mill scale is visible
on girder webs.

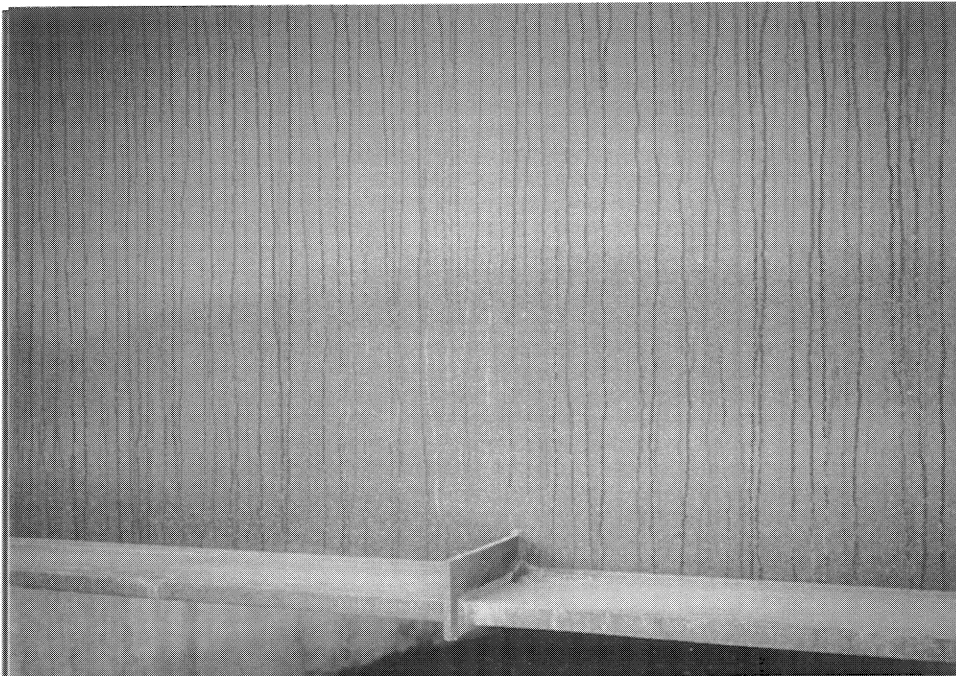
Photo No. 16

View of exterior girder.
Note drip plate on bottom
flange and condensation
lines.

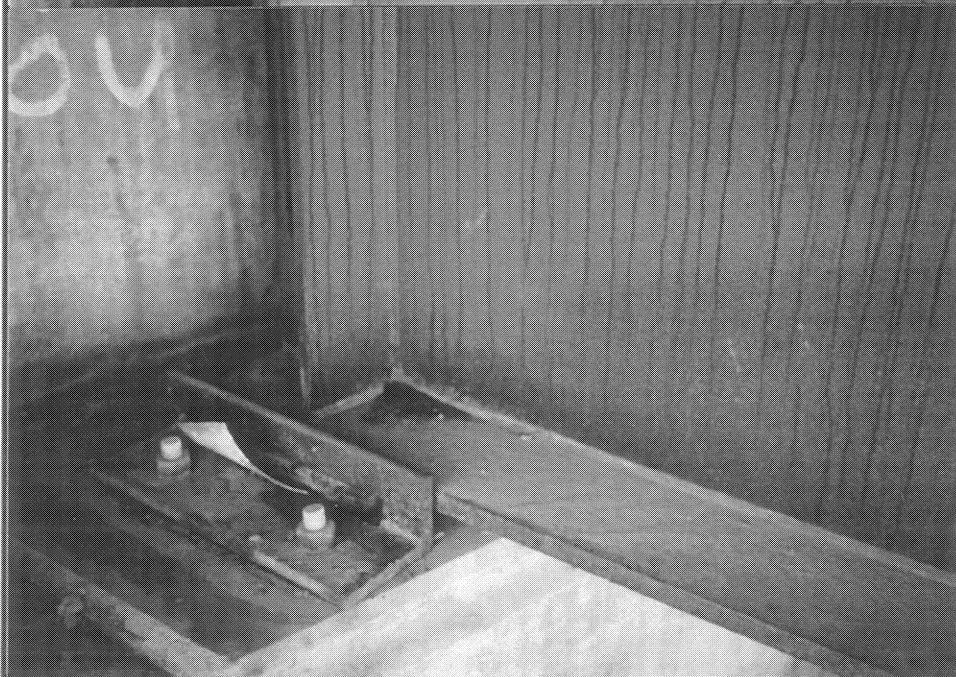
Photo No. 18

East exterior girder
bearing at South Abut-
ment. Note the TFE
sheet protruding through
the angle.

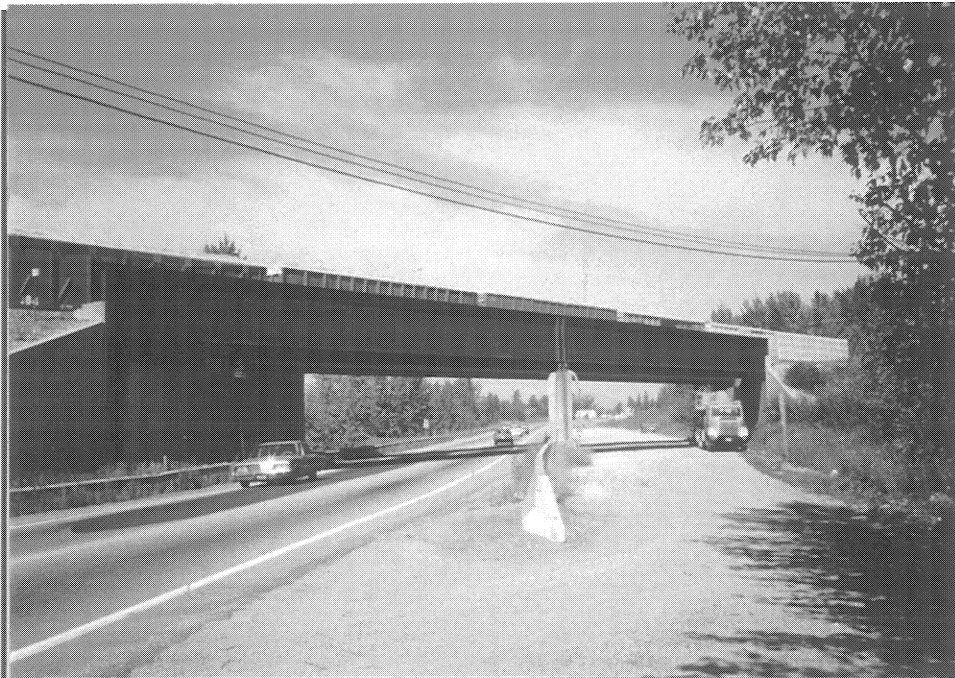
Photo No. 19
View looking north.
Note uniform dark brown
color.

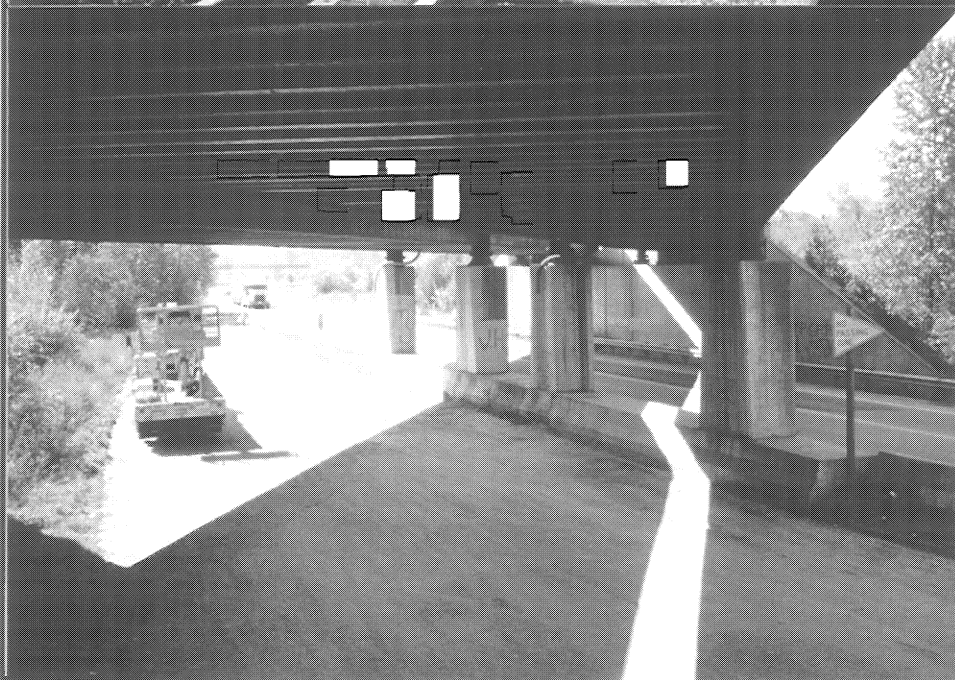
STAINING OF SUBSTRUCTURE: The most notable staining of substructure concrete surfaces was found on the piers of the Ponderay Underpass and the Snake River Bridge near American Falls. Both of these bridges were built more than twenty (20) years ago and well before ITD had adopted current practices to minimize staining. Neither bridge had drip plates (water deflector plates) on the bottom flanges. Also there was no requirement to protect surfaces of the substructure from staining by wrapping with plastic or other approved material until deck placement has been completed.

Photo No. 21
View from East Abut-
ment. Note staining on
pier columns.

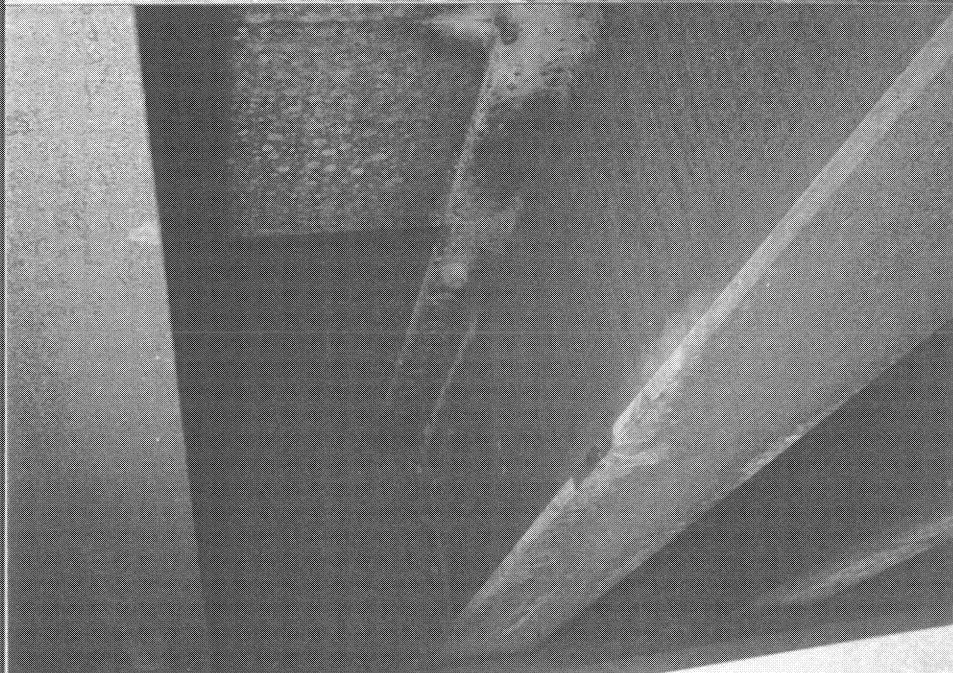
The railroad bridges at Ponderay and Vista have sliding plate joints. The joints on the Ponderay Bridge are leaking but are not causing a serious problem at this time. The sliding plate joints with compression seals on the Vista Bridge were not inspected. These joints are covered with ballast.

Photo No. 23
View of bottom of deck
plate and floor beam.
Note discoloration at top
center from leak.

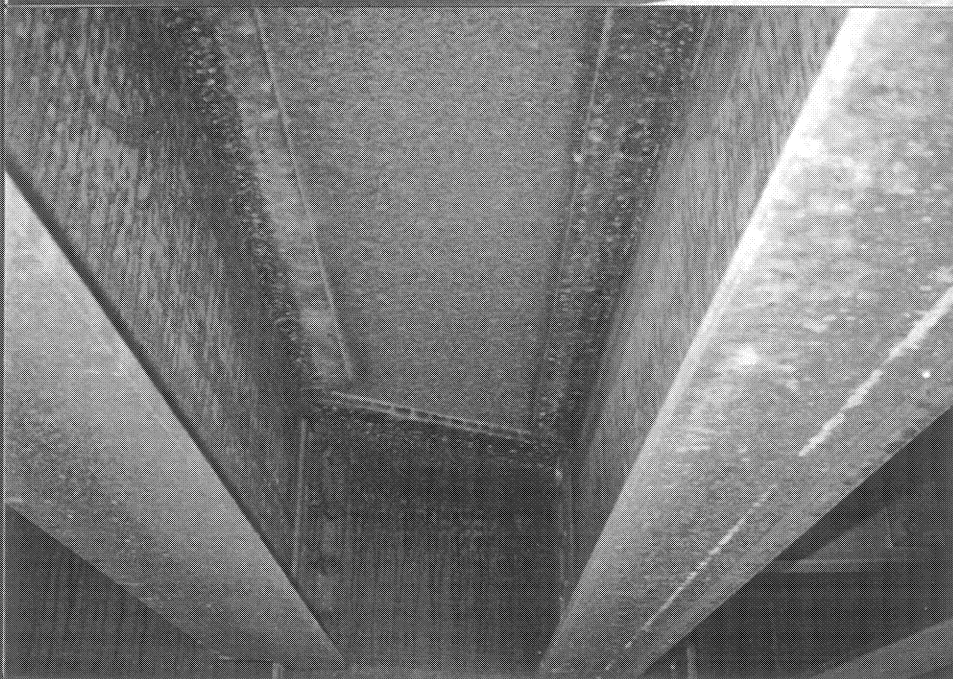
Photo No. 24
View of bottom of deck
plate and floor beams.
Note yellow color of
floor plate.

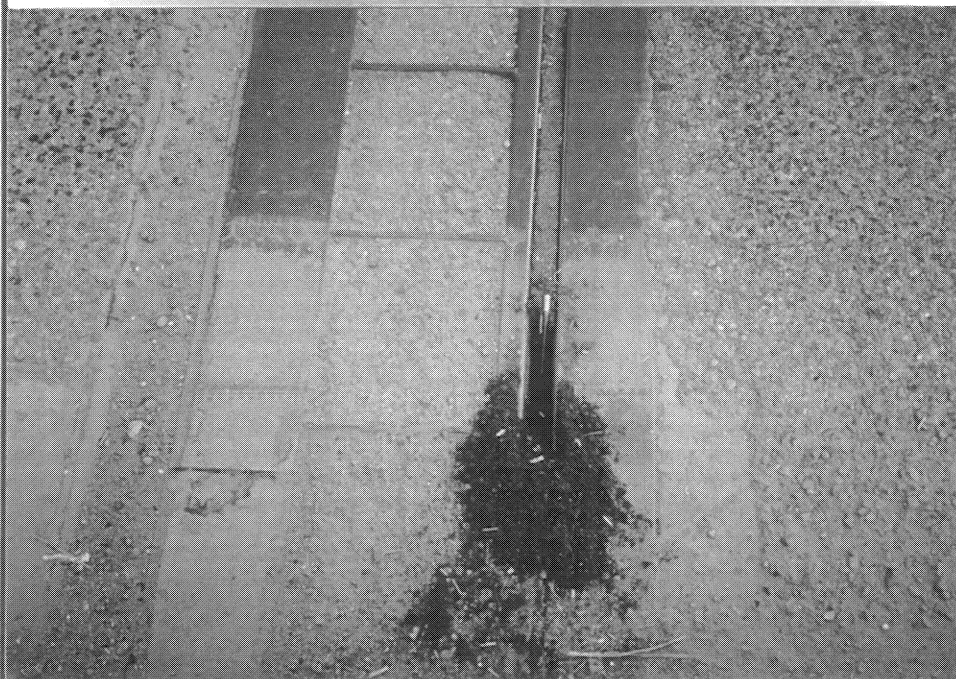
The NW Caldwell IC has a strip seal joint at each abutment. The joint at the west abutment is leaking, but water is not getting on the steel members, and no corrosion was found. The seal is about 3 inches below the deck surface and is full of dirt and sand. This type of joint requires frequent cleaning.

Photo No. 27
Top view of deck
expansion joint at
Abutment 1. About 3" of
sand and dirt is in joint.

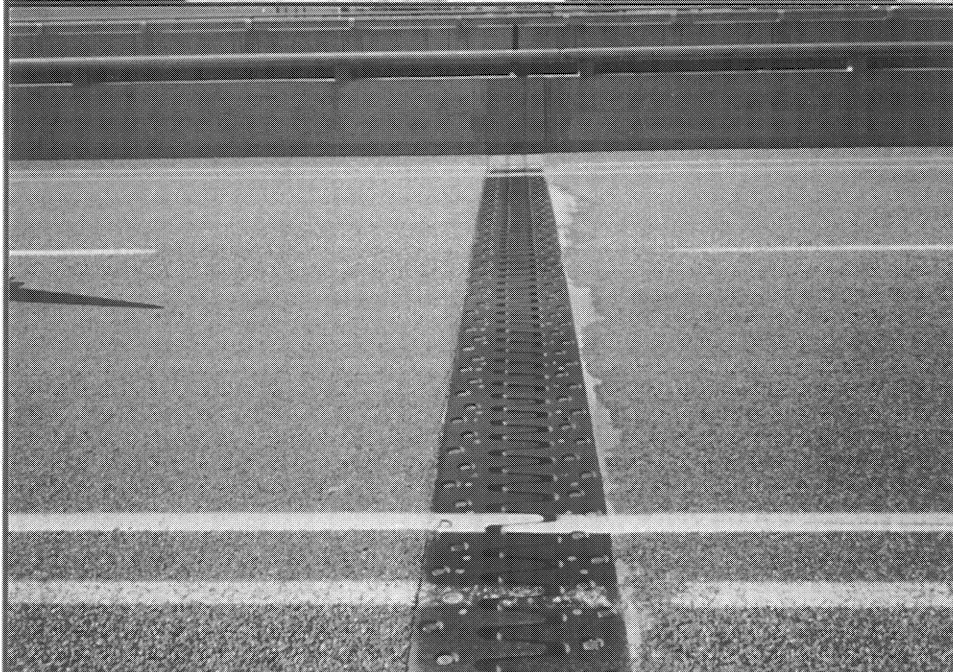
Photo No. 32
Top view of deck
expansion joint at Pier 3.
Note asphalt ship seal on
the deck.

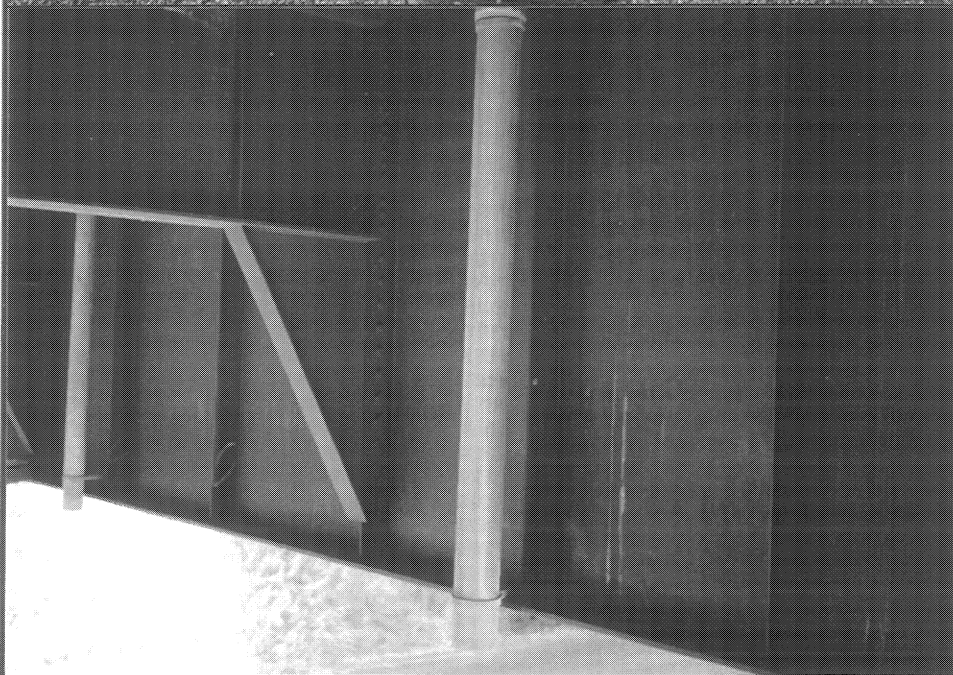
Photo No. 33
View of interior face of
girder. Note drainpipe
from trough under the
deck joint

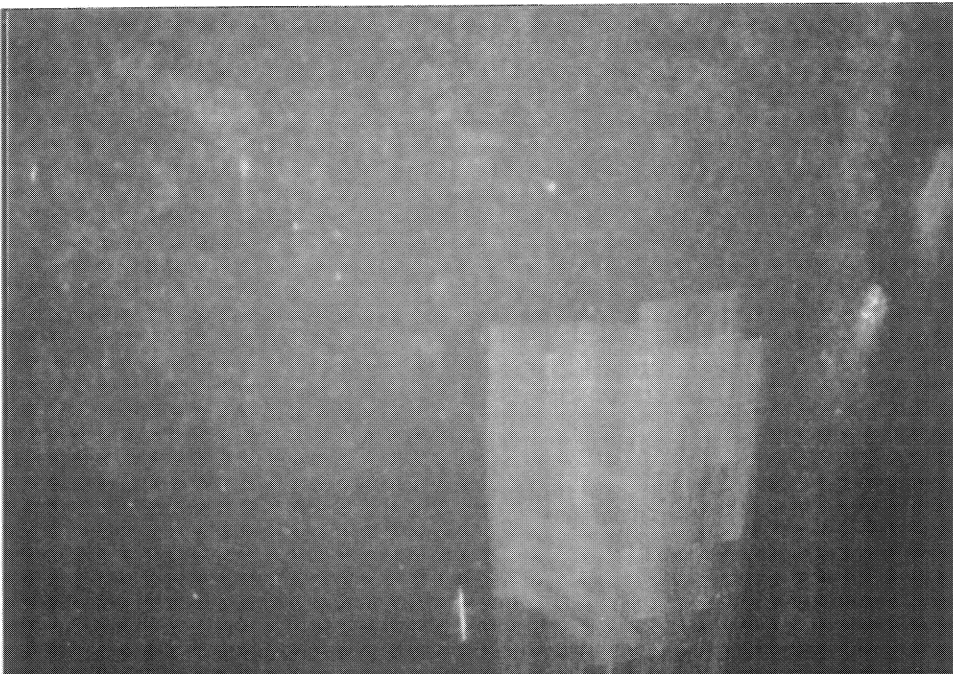
Photo No. 34

View of exterior face of
web near West Abutment
showing scraped and
brushed areas and
tightness of coating.

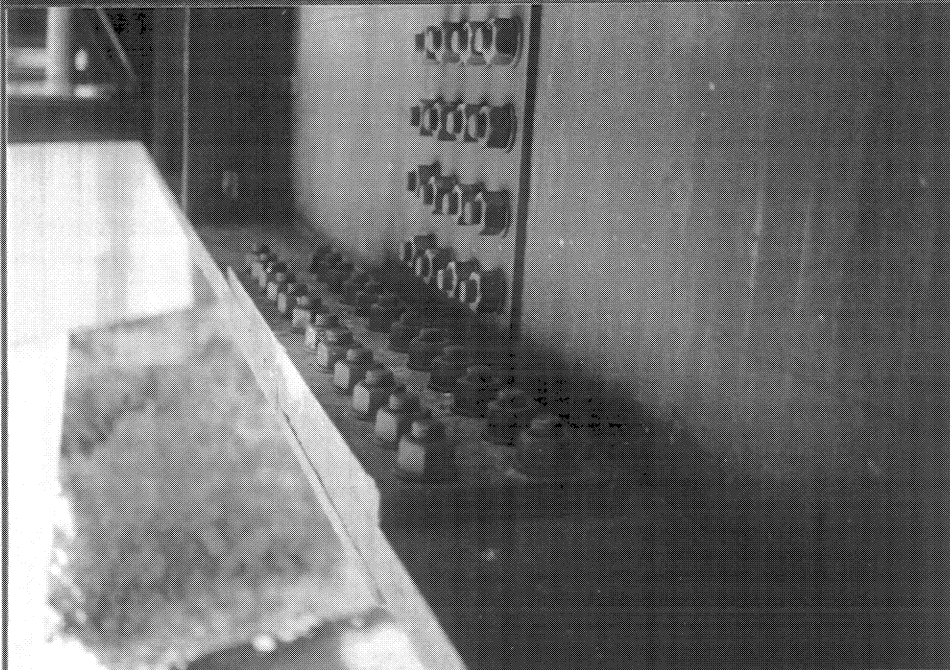
Photo No. 35

Bolted field splice in
Span 3. Light staining is
visible on pier cap.

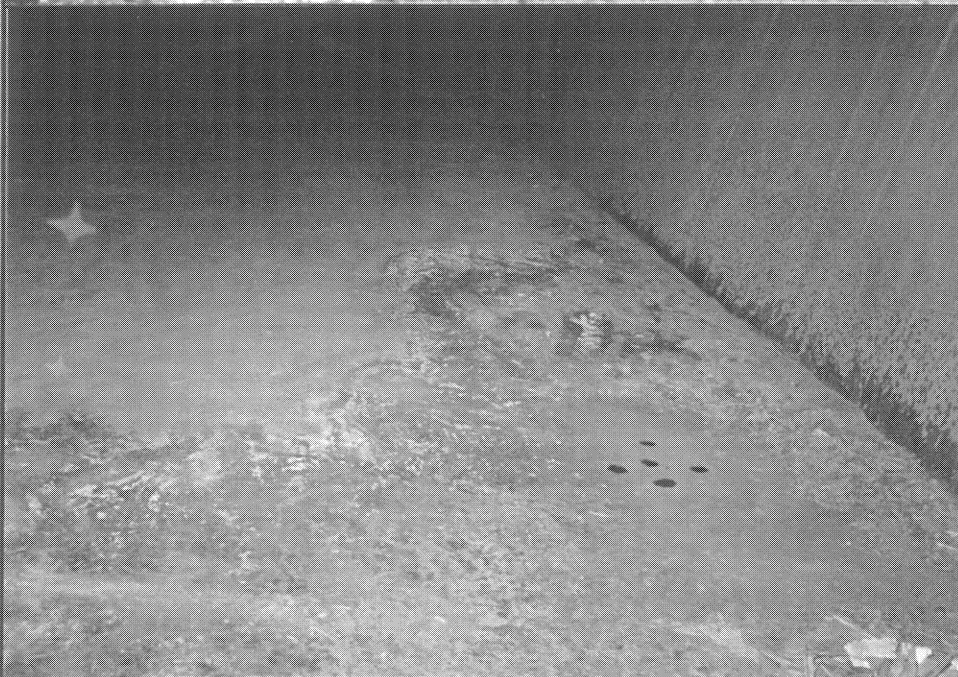
Photo No. 39
Inside view of east box
girder bottom flange near
North Abutment. Note
the field drilled drain
holes.

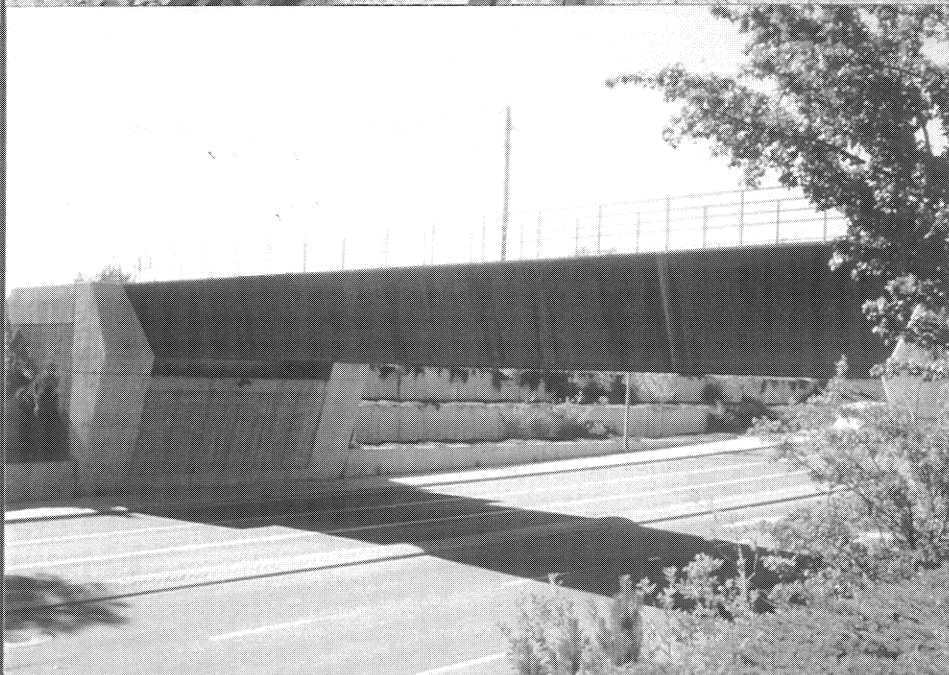
Photo No. 45
View of north girder.
Note vertical stains at top
flange breaks.

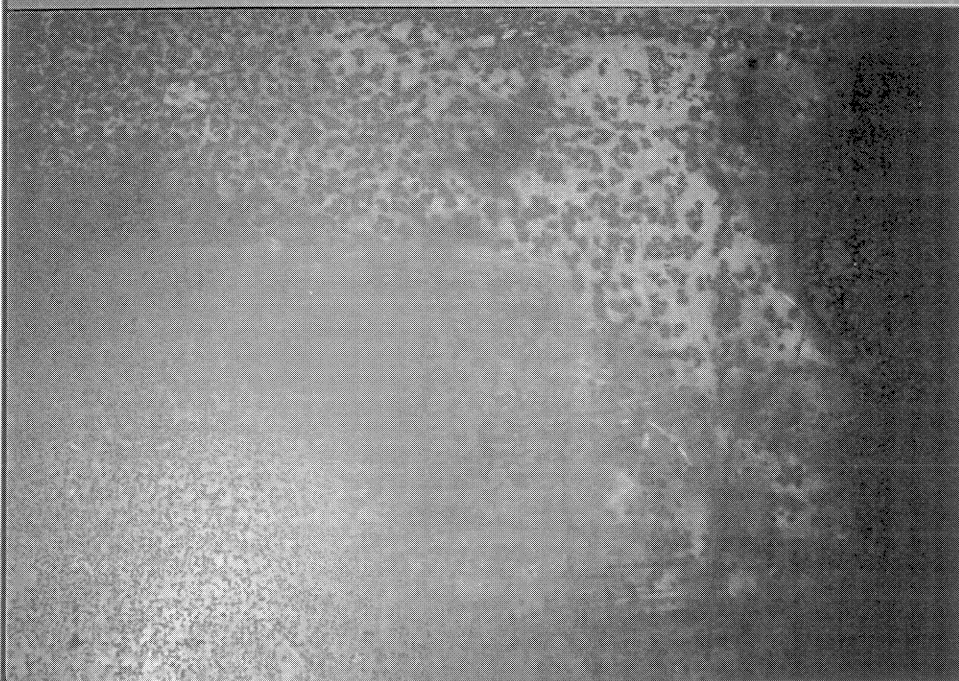
Photo No. 54
View of interior girder
showing mill scale and
area that was wire
brushed.

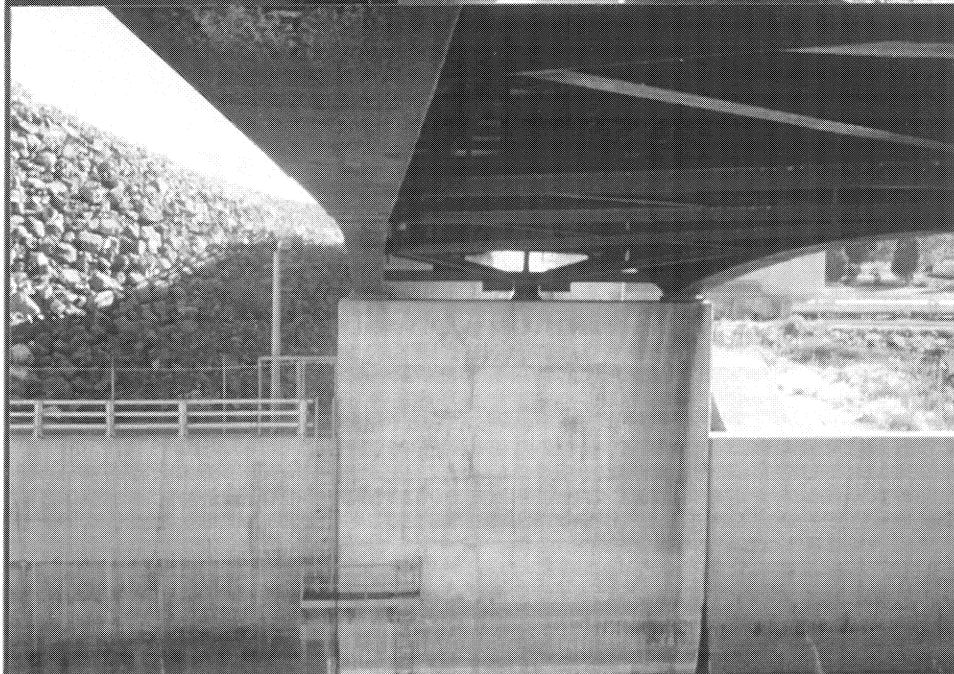
Photo No. 57
View of Pier 6 with dark
stains showing on pier
under south girder.

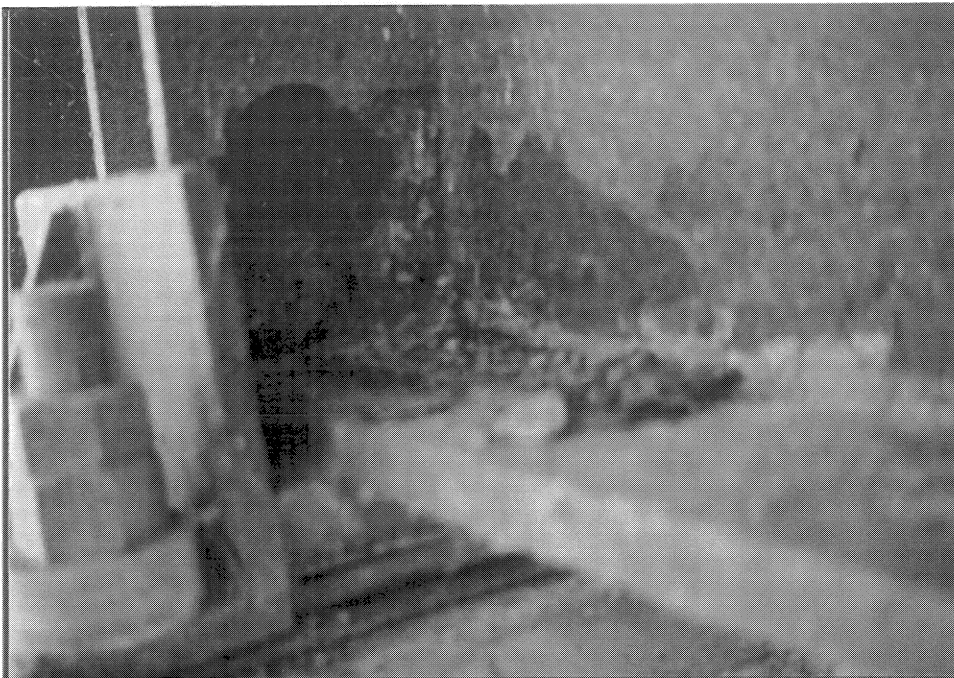
Photo No. 58

LAMINAR CORROSION - LOSS OF SECTION: No significant loss of section was found on any of the twelve (12) Idaho bridges inspected. See plate thickness measurements in Appendix D. However, localized areas of laminar or large flake corrosion with the probability of some slight loss of section were found on the Bonners Ferry Bridge, Ninth St. Bridge, American Falls Bridge and the Broadway Bridge. See reports on these bridges for specifics in Appendix A.

View of north girder
bottom flange at Pier 4,
Span 3. Note laminar
corrosion on web and
bottom flange.

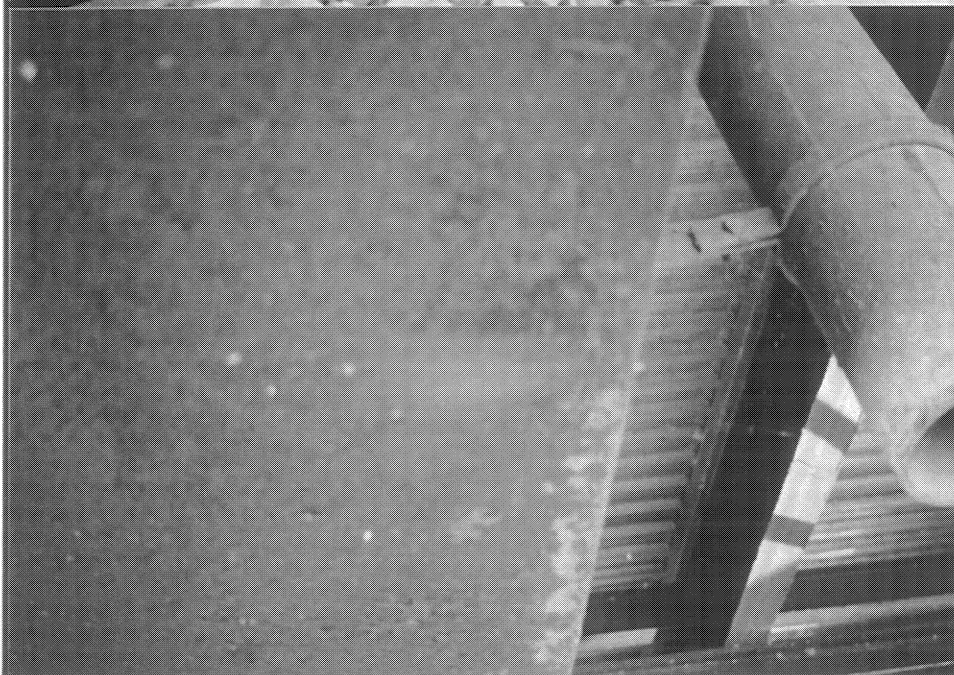
Photo No. 60

DECK DRAINS: Except for the American Falls Bridge, the deck drains were found to be functioning properly in keeping roadway drainage water away from the steel members. Some of the drain pipes on the American Falls Bridge in spans 3, 4 and 5 stop at or near the bottom flange, allowing drainage water to blow onto the bottom girder flange. Light corrosion was found on the north girder bottom flange, but did not occur at all drain pipes. This condition should be investigated to see if the problem drains can be plugged or pipes extended. Washing the steel in these areas to remove chlorides is recommended.

View of bottom flange of
north girder of Span 5
near deck drainpipe.

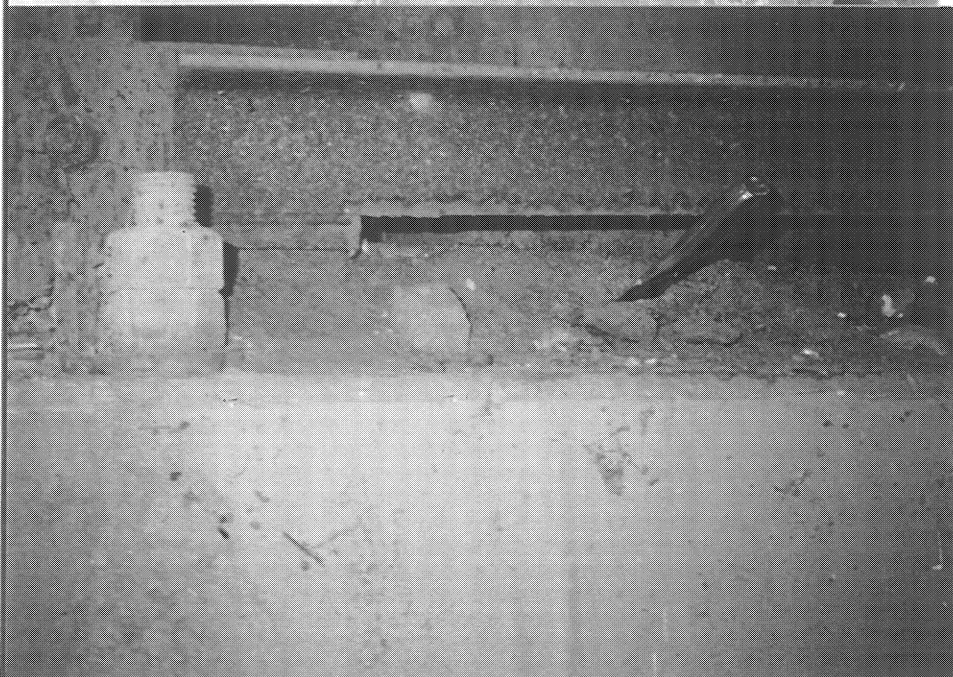
Photo No. 63
View of Pier 1 beam seat.
Note large amount of dirt
and debris.

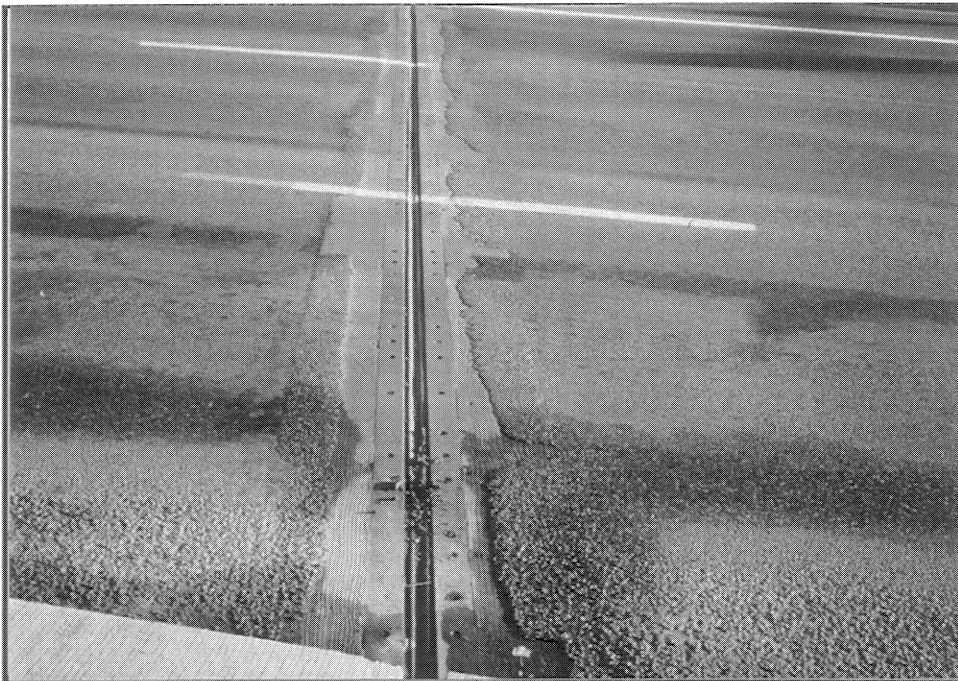
Photo No. 64

Top view of deck
expansion joint at pier.
Note the asphalt chip seal
on the deck.

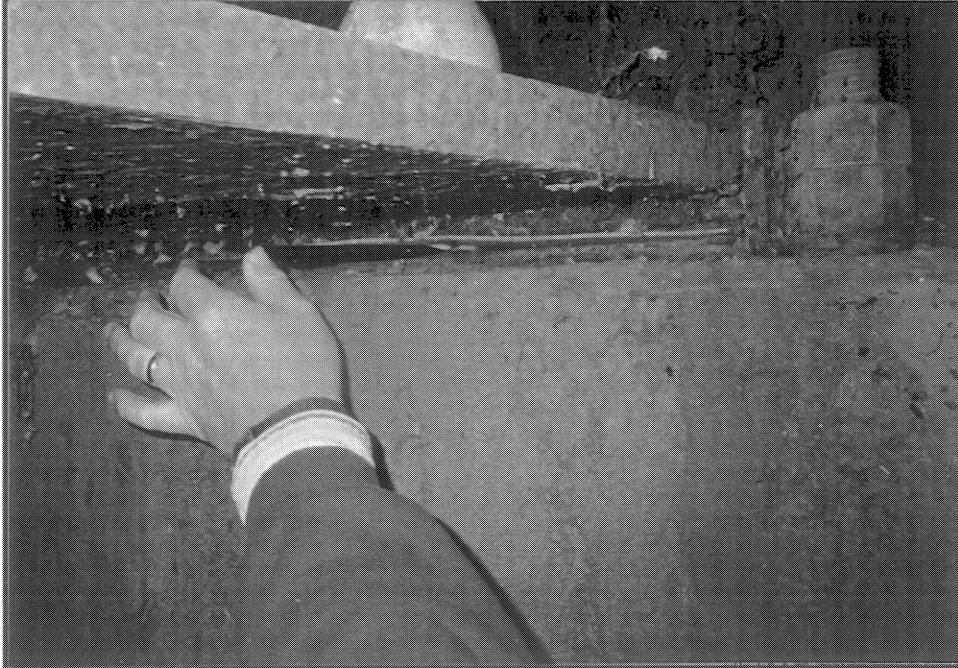
Photo No. 65

View of bearing on south
side of first interior girder
at Pier 1. Note the TFE
sheet is loose and coming
out.

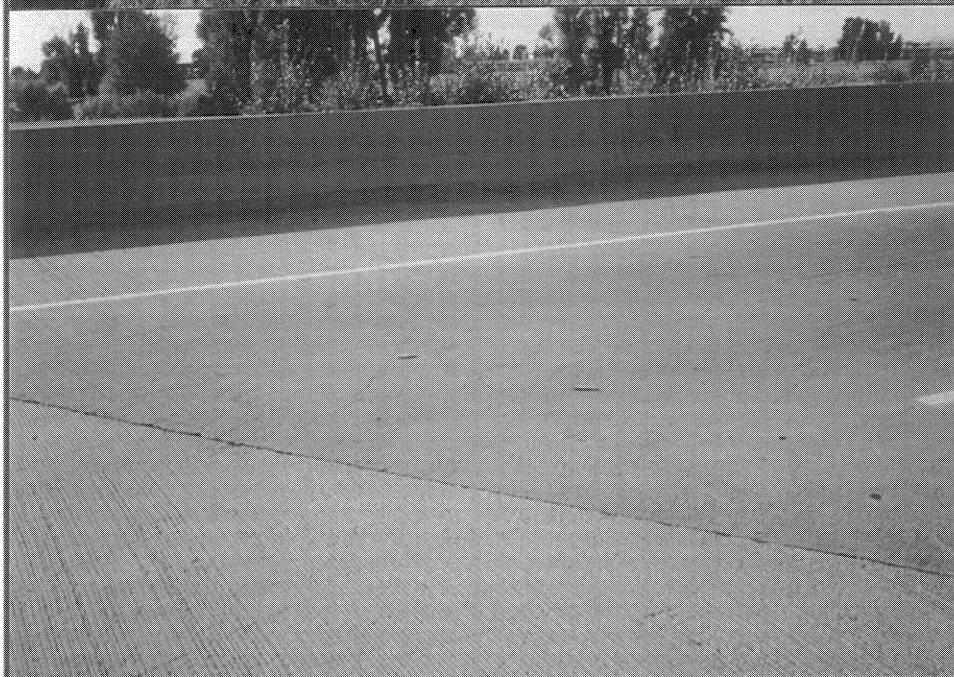
DECKS: The concrete decks on the inspected bridges were found to be in good condition. Most decks had minor hairline transverse cracks. Random cracking in the top of the deck was observed on the South Fork Teton River Bridge. No evidence of roadway drainage water leaking through deck cracks and onto the steel was observed.

Photo No. 67
View of top deck and
approach slab. Note the
cracks.
